COMPREHENSIVE MOTOR VEHICLE SERVICES & CONSULTING Motor Vehicle Forensic Analysis Report

People of the State of New York v.
Nauman Hussain

REFERENCED INVOLVED SUBJECT VEHICLE: 2001 Ford Excursion Stretch Limousine,
VIN 1FMNU40S51EB10299

MOTOR VEHICLE AUTOPSY FORENSIC INVESTIGATION SUMMARY

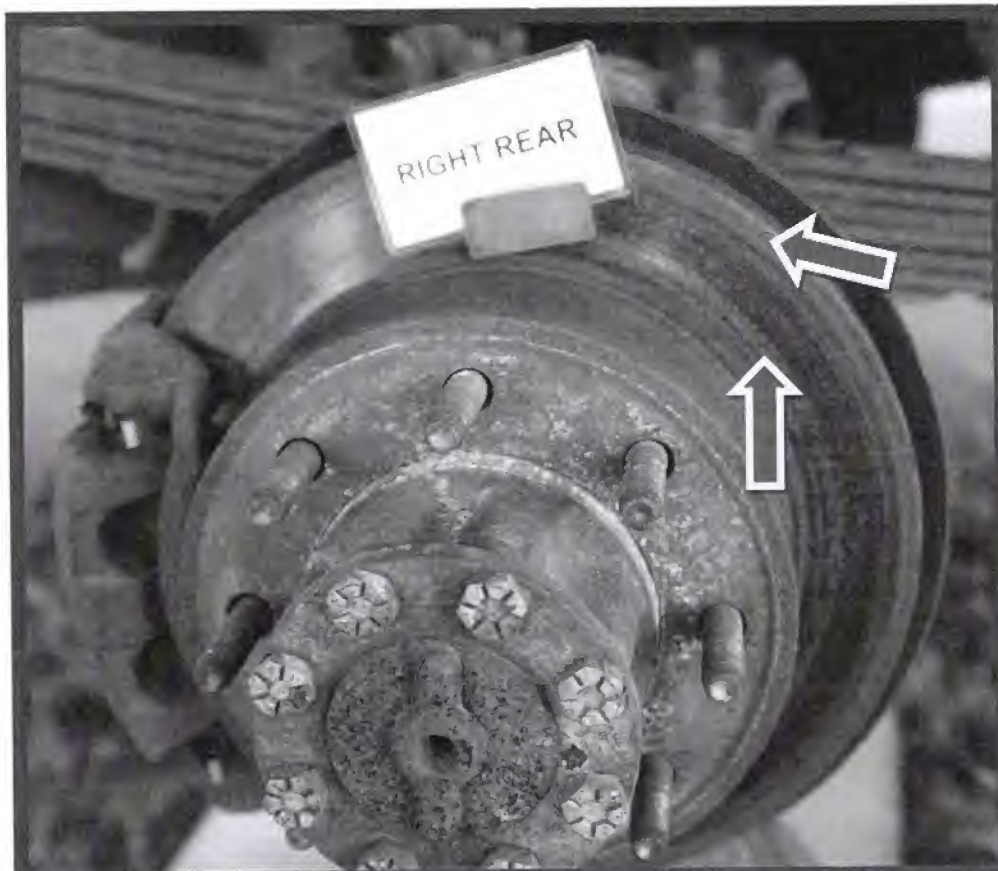
Image No.21. This photograph depicts the right rear disc brake components of the involved 2001 Ford Excursion stretch limousine prior to removal from the vehicle. Note the outer disc brake rotor swept area corrosion, which was a pre-existing condition (Red Arrows).

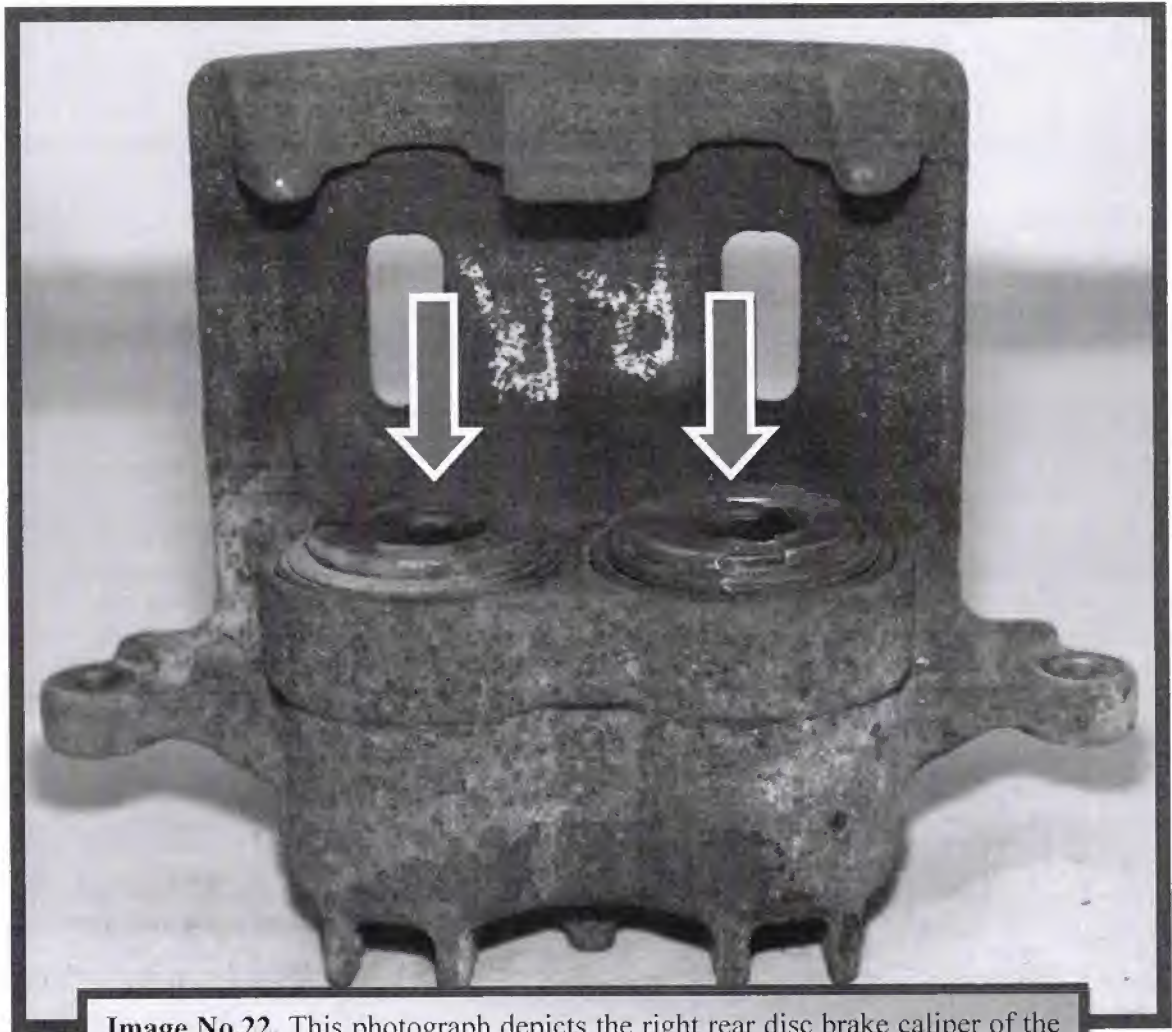
Disc Brake Caliper, Right Rear – The right rear disc brake caliper of the 2001 Ford Excursion stretch limousine exhibited prominent casting corrosion; corrosion/pitting at the outer disc brake pad flange; and remarkable corrosion at the bleeder valve area. The two brake caliper pistons were seized within the respective caliper housing bores, rendering brake force nonexistent at the right rear wheel location. This condition was pre-existing.

Image No.22. This photograph depicts the right rear disc brake caliper of the involved 2001 Ford Excursion stretch limousine prior to removal from the vehicle. Note the prominent corrosion -- the caliper was that of an older design, with steel composition pistons as opposed to phenolic pistons. The two caliper pistons were seized within their respective bores of the caliper body (Blue Arrows) -- a pre-existing condition.

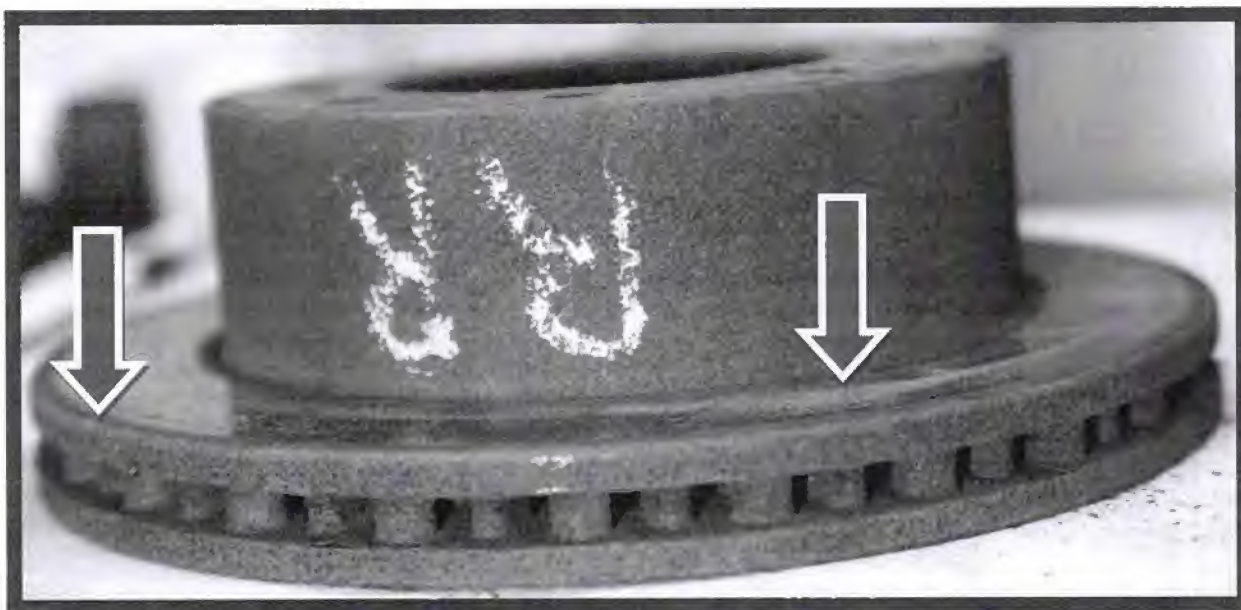
Disc Brake Rotor, Right Rear – The examination and forensic analysis of the right rear disc brake rotor of the 2001 Ford Excursion stretch limousine revealed that of a heavy duty, eight (8) stud hole, cast disc brake rotor. The right rear disc brake rotor exhibited evidence of pre-existing inoperable brake effort at the right rear wheel location of the 2001 Ford Excursion stretch limousine, including negligible brake friction wear conditions despite alleged 2016 replacement and oxidation/corrosion of inner/outer swept areas.

- ✓ No thermal distress noted.
- ✓ Minimal brake dust presence.
- ✓ Outer swept area exhibited corrosion, oxidation, pitting, and scoring.
- ✓ Inner swept area exhibited corrosion, pitting, and scoring.
- ✓ Condition consistent with deficiencies in effective brake effort.
- ✓ Disc brake rotor was not machined/replaced during brake service conducted by Mavis Discount Tire on May 11, 2018.
- ✓ Minimum measured right rear disc brake rotor thickness = 1.183". Original disc brake rotor thickness = 1.185". Minimum disc brake rotor thickness specification = 1.10". Minimum disc brake rotor thickness to machine rotor specification = 1.12".
- ✓ Reduced brake component cooling due to heavy corrosion at cooling fins.

- ✓ Disc brake rotor thickness measurements revealed merely negligible wear from braking, despite alleged rotor replacement on September 10, 2016¹³.
- ✓ Park Brake maximum measured diameter = 8.104". Park Brake maximum diameter specification = 8.157".
- ✓ Disc brake rotor swept area measured parallelism = 0.010". Maximum typical parallelism = 0.0005".
- ✓ Disc brake rotor swept area measured lateral runout = 0.011". Maximum typical lateral runout = 0.0008".

Image No.23. This photograph depicts the right rear disc brake rotor of the involved 2001 Ford Excursion stretch limousine during the period of individual component analysis. Note the oxidation/corrosion present at the outer rotor swept area, as well as absence of wear evidence from braking since replacement in 2016. (Red Arrows), consistent with the previously described condition of pre-existing seized brake caliper pistons which prevented brake application at the right rear wheel location.

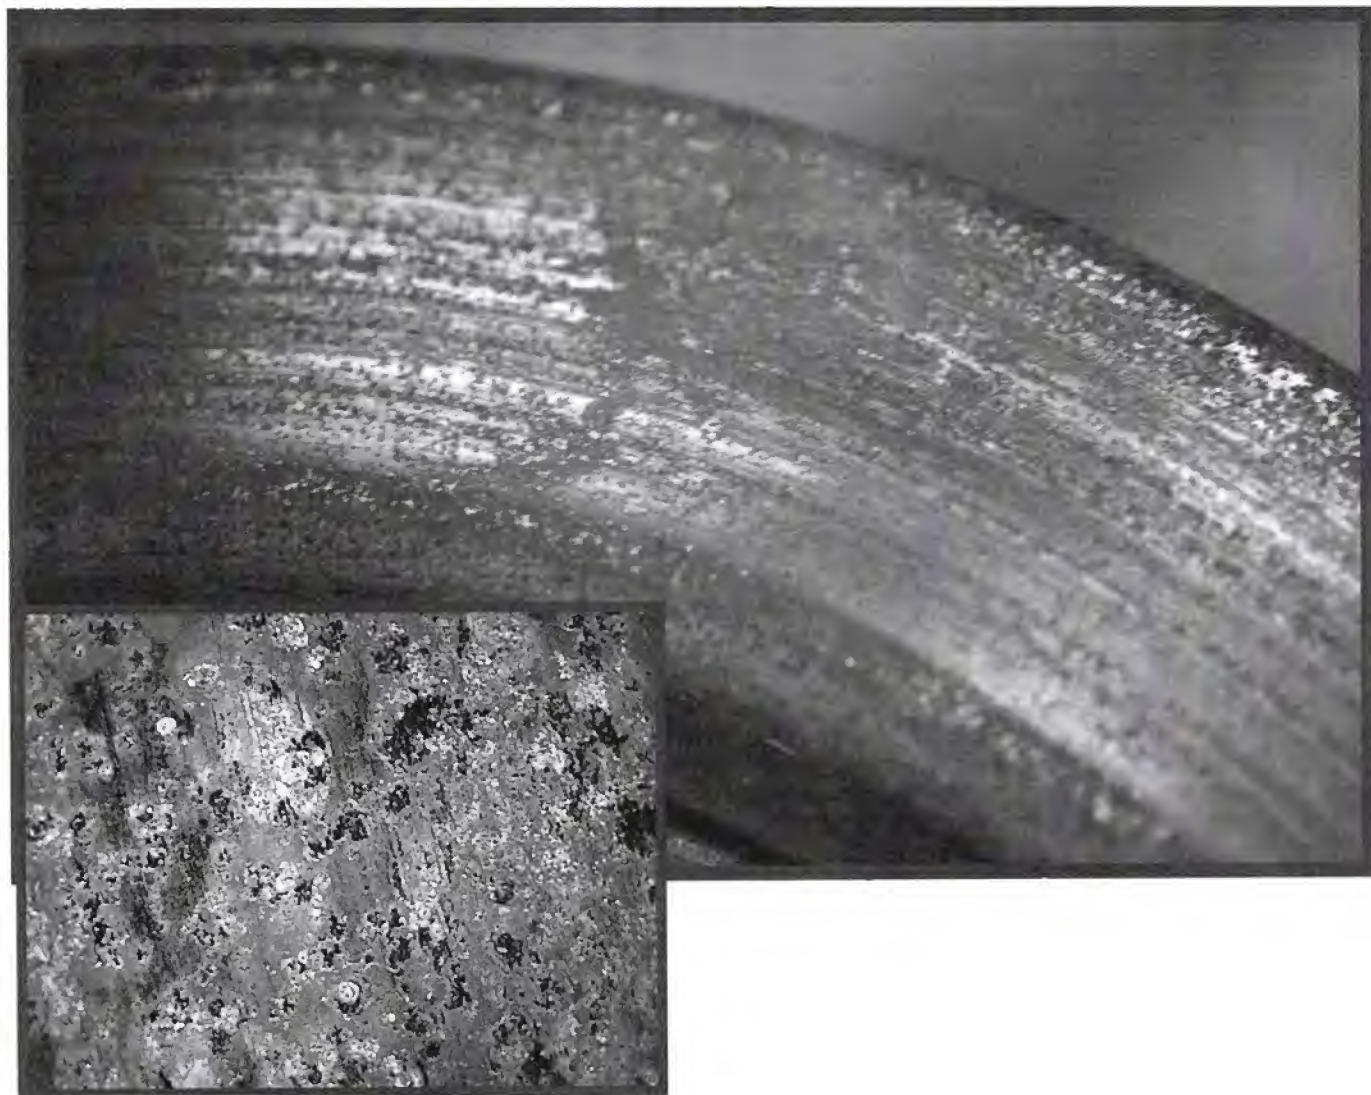
Image No.24. This photograph depicts the inner swept area of the right rear disc brake rotor of the involved 2001 Ford Excursion stretch limousine during the period of individual component analysis. Note the oxidation/corrosion/pitting present within the outer rotor swept area, as well as absence of wear evidence from braking since replacement in 2016, consistent with the previously described condition of pre-existing seized brake caliper pistons which prevented brake application at the right rear wheel location. Insert digital microscope image denotes swept area surface.

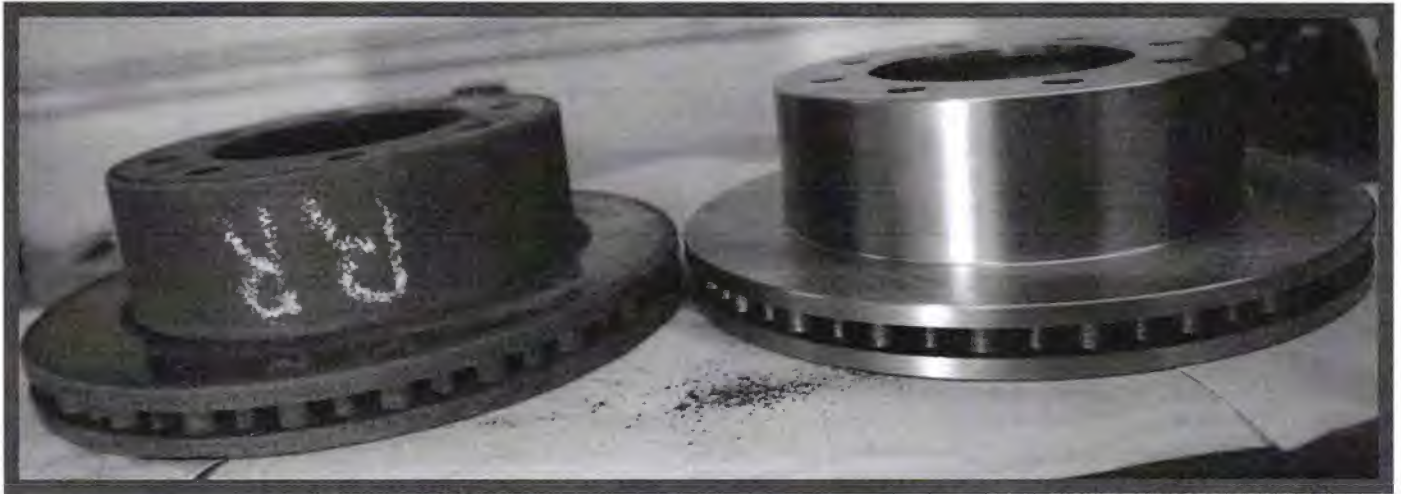
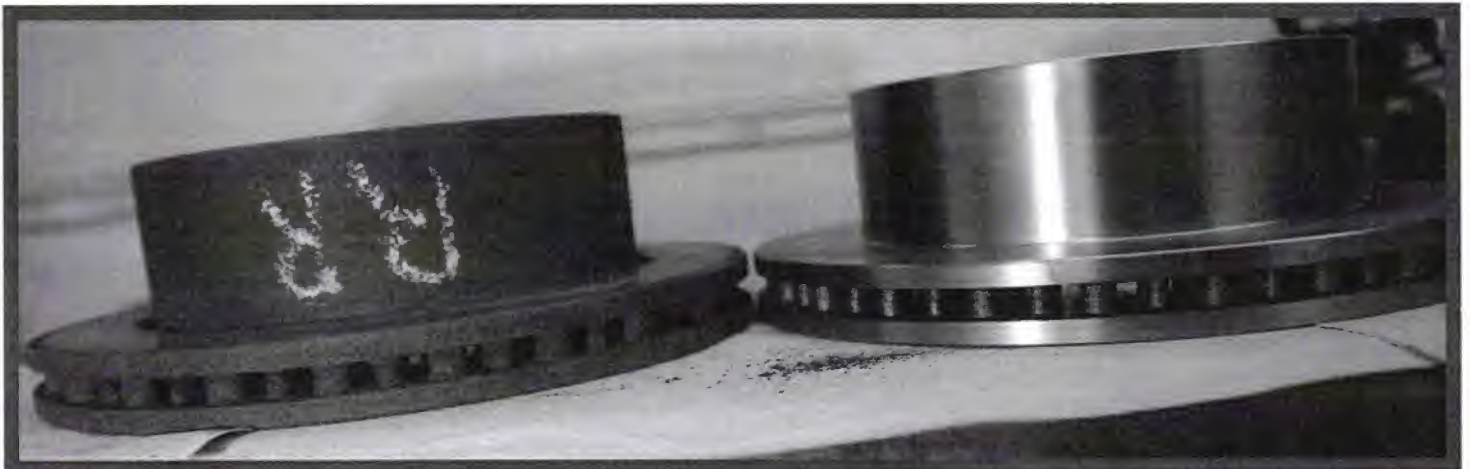
Images No.25a & 25b. These photographs depict the comparison of the right rear disc brake rotor of the involved 2001 Ford Excursion stretch limousine to a new replacement disc brake rotor. Note that the removed rotor thickness and lack of wear ridge is consistent with the previously described condition of pre-existing seized brake caliper pistons which prevented brake application at the right rear wheel location.

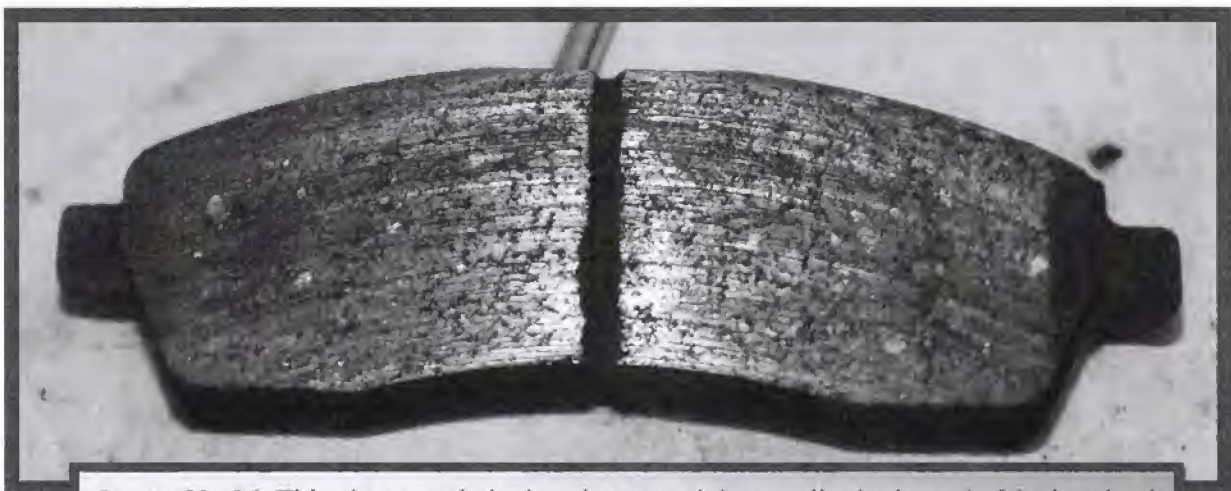
- ✓ Digital measurements of friction material thicknesses of outer disc brake pad 0.378" - 0.420", with tapered wear. Original friction material 0.460". Corrosion present at abutment clip locations.
- ✓ Digital measurements of friction material thicknesses of inner disc brake pad 0.338" - 0.394", with tapered wear. Original friction material 0.460". Corrosion present at abutment clip locations.
- ✓ Bonded design disc brake pads, ceramic composition.
- ✓ Brake dust presence minimal, noted at center friction material pad groove due to previous gassing delamination. Superficial friction material contamination.
- ✓ No thermal distress noted.

Image No.26. This photograph depicts the outer right rear disc brake pad of the involved 2001 Ford Excursion stretch limousine. The friction material exhibited slight scoring, pitting, and contaminants.

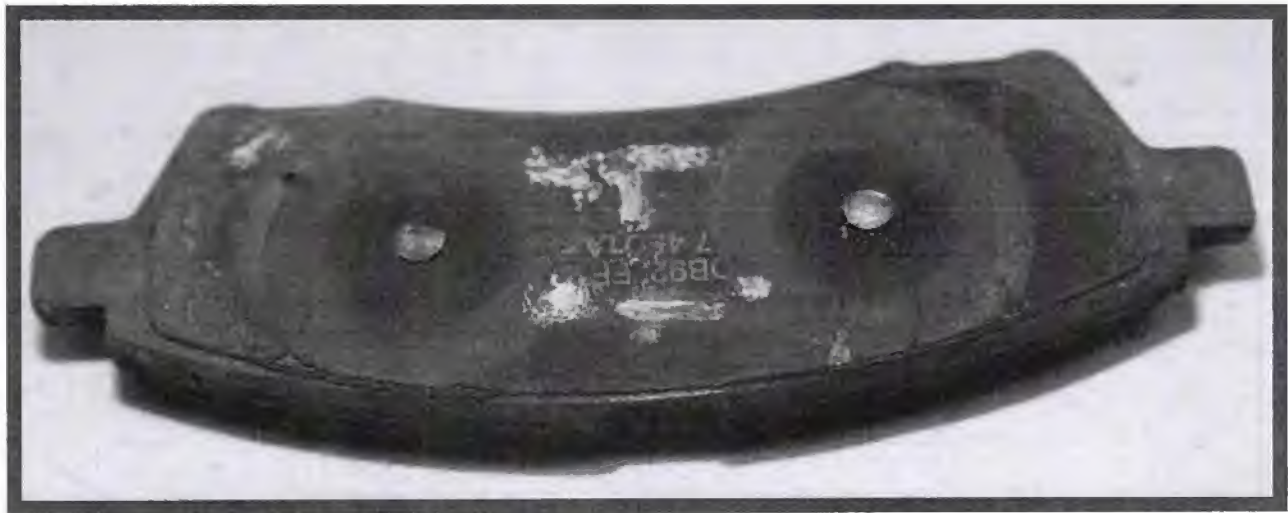
Image No.27. This photograph depicts the inner right rear disc brake pad of the involved 2001 Ford Excursion stretch limousine. Obvious corrosion was present at the inner/outer disc brake pad shim; abutment clip locations; and caliper piston/pad shim interfaces.

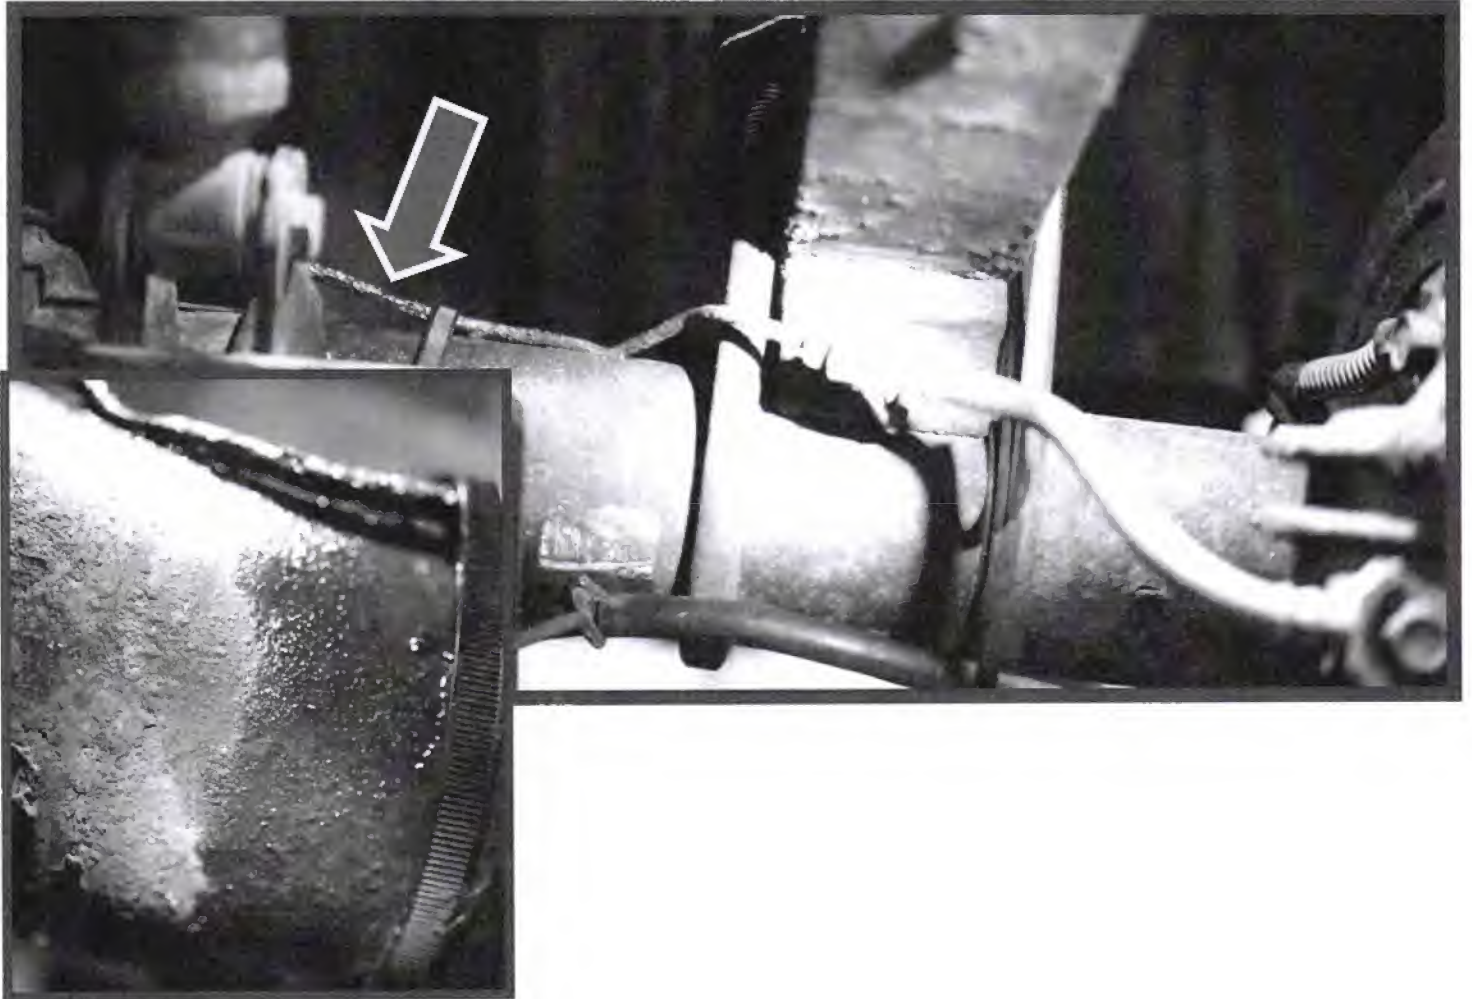
Brake Tubing, Right Rear – The examination of the steel composition, rear crossover brake tubing located on the rear differential housing of the involved 2001 Ford Excursion stretch limousine revealed that the section of tubing had experienced failure of integrity, with resulting loss of brake fluid, due to pre-existing critical tubing corrosion. This loss of integrity is typically associated with considerable brake pedal force executed by the operator of the vehicle.

Due to the mandated split service design of the hydraulic braking system of the 2001 Ford Excursion stretch limousine, this loss of integrity at the right rear crossover brake tubing would result in overall brake failure at both left and right rear wheel locations of the vehicle -- braking of the 2001 Ford Excursion stretch limousine would be totally dependent upon the left and right front brake components only.

Image No.28. This photograph depicts the rear crossover section of brake tubing, at the right rear differential housing axle tube of the 2001 Ford Excursion stretch limousine. The obvious perilous corrosion of the length of steel composition brake tubing resulted in a catastrophic loss of integrity (Red Arrow), with brake fluid loss clearly discernible from the insert photograph. The loss of integrity resulted in no braking action at the left and right rear wheel locations.

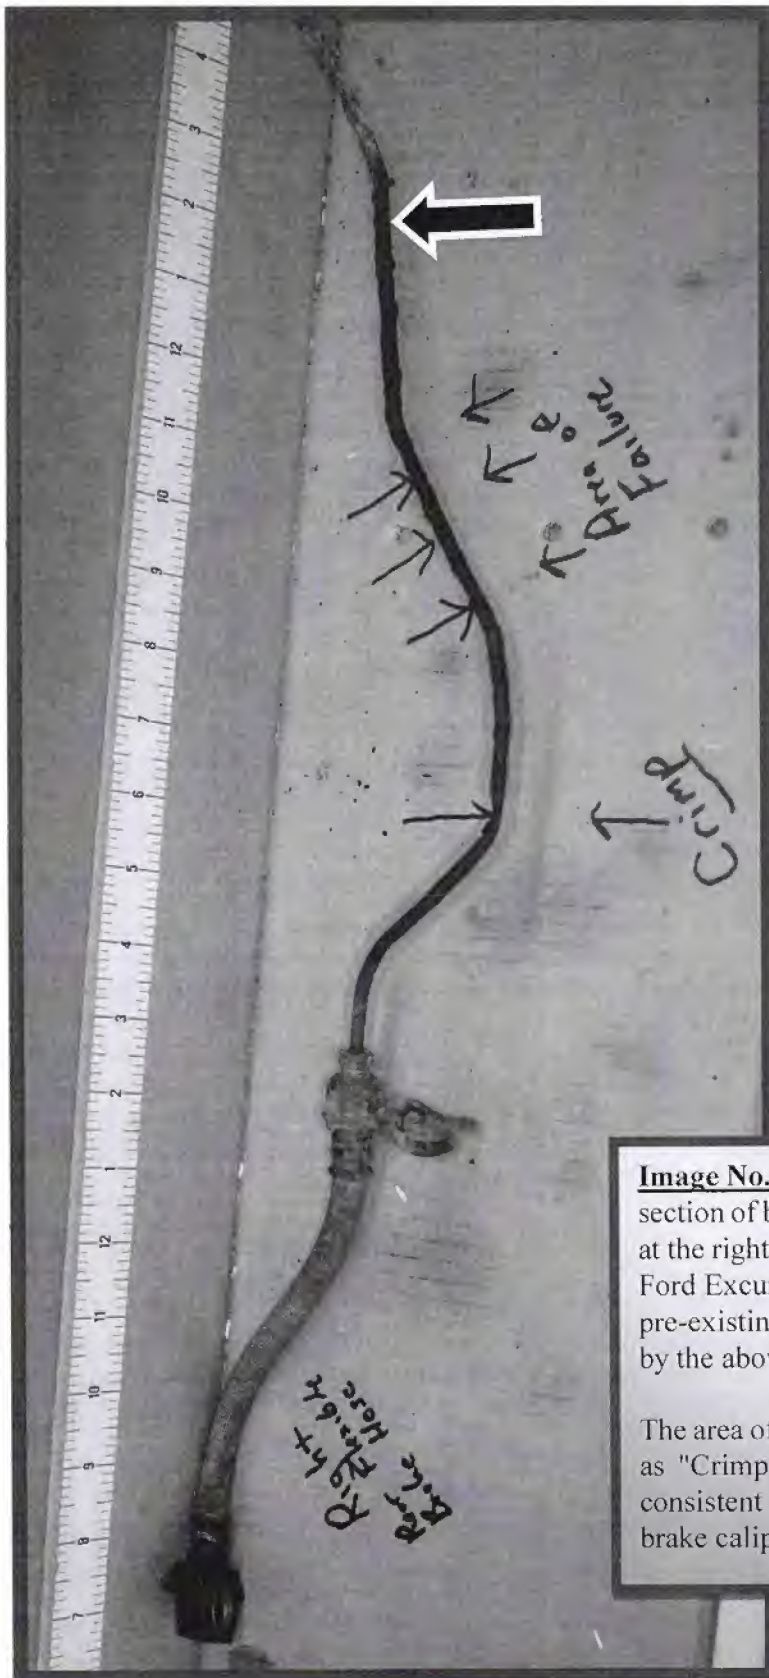
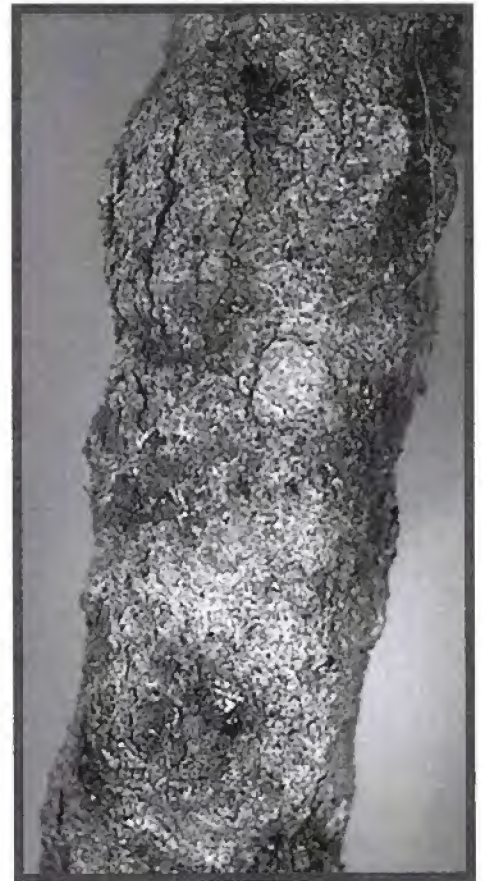
Image No.29. This photograph depicts the rear crossover section of brake tubing, removed from the design location at the right rear differential housing axle tube of the 2001 Ford Excursion stretch limousine. The obvious extent of pre-existing corrosion can be readily denoted, as depicted by the above photograph in the area of the Black Arrow.

The area of the steel composition brake tubing designated as "Crimp" is that of partially collapsed brake tubing, consistent with improper removal of the right rear disc brake caliper of the vehicle.

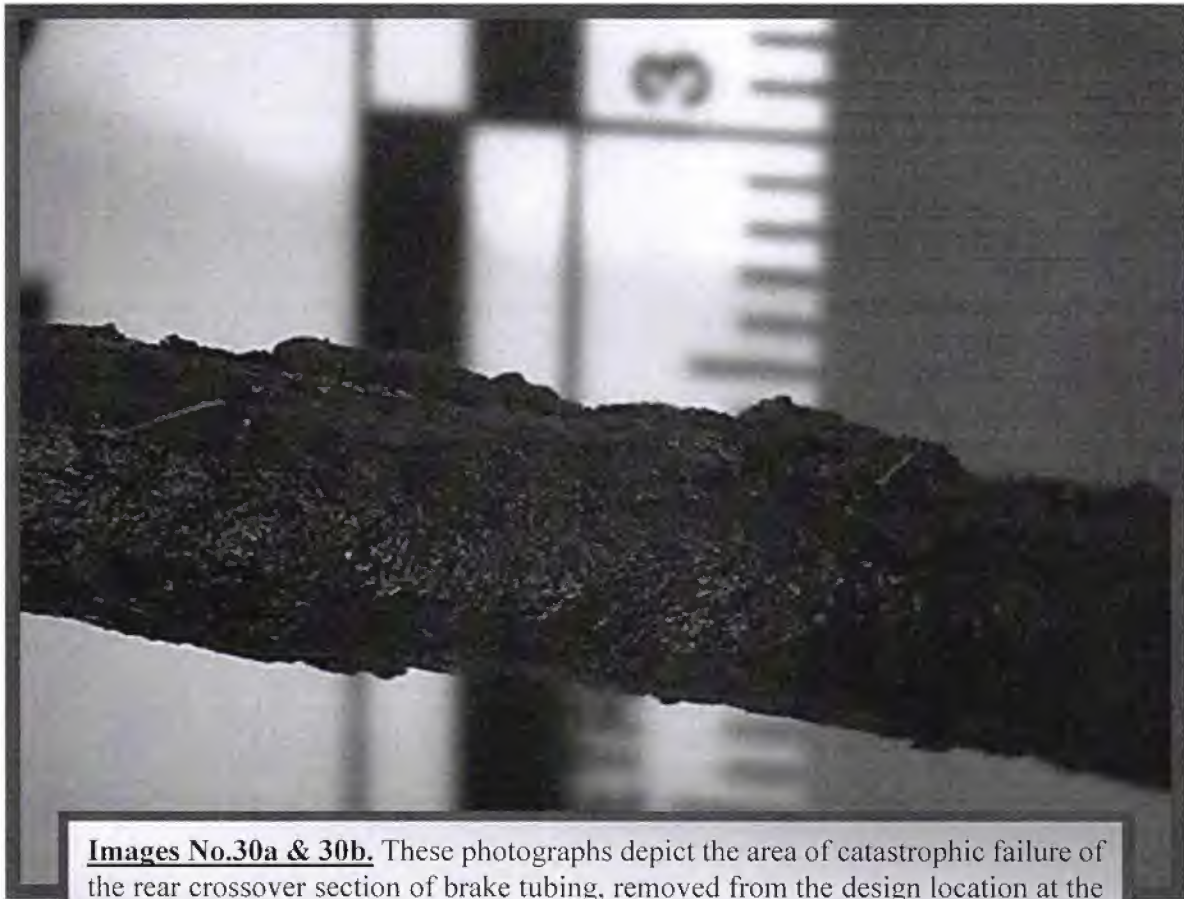
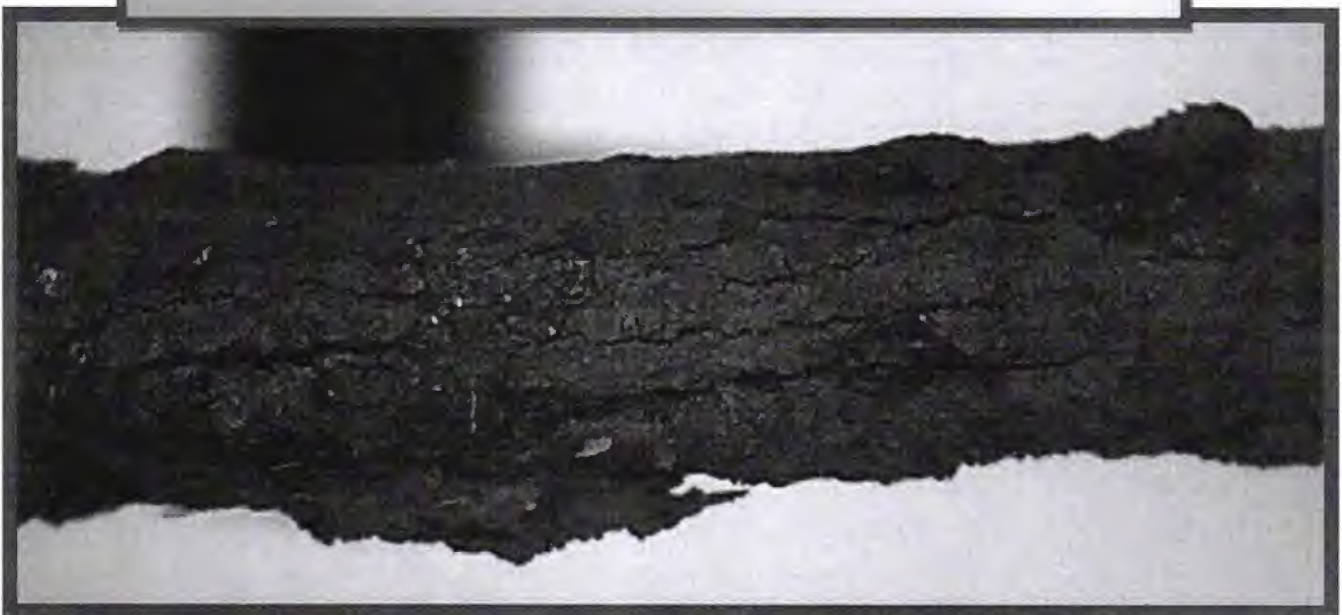
Images No.30a & 30b. These photographs depict the area of catastrophic failure of the rear crossover section of brake tubing, removed from the design location at the right rear differential housing axle tube of the 2001 Ford Excursion stretch limousine. Again, the obvious extent of pre-existing corrosion can be readily denoted.

Summary of Forensic Analysis, Right Rear Brake System Components: *No braking effort whatsoever in effect at the right rear wheel location of the 2001 Ford Excursion stretch limousine. Condition was pre-existing, as supported by forensic evidence and the absence of obvious brake dust at locations inclusive of the right rear alloy wheel.*

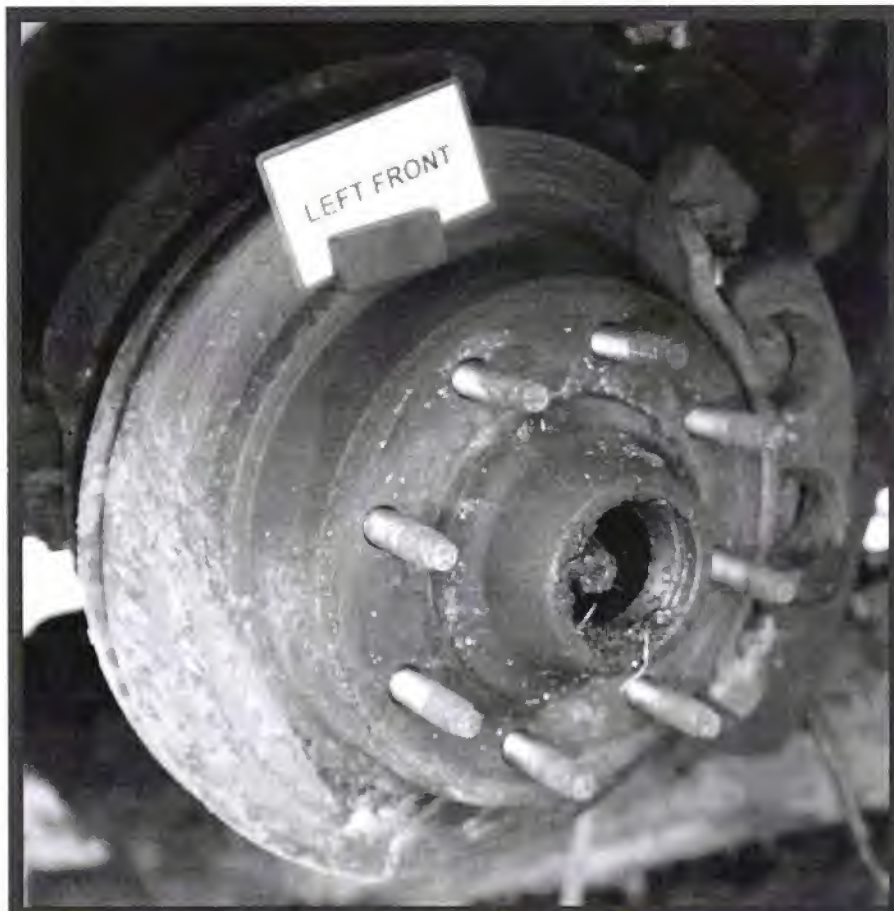
Image No.30. This photograph depicts the left front disc brake components of the 2001 Ford Excursion stretch limousine. The violent crash forces resulted in abstraction of the outer wheel bearing, washer, and spindle nut. The pungent odor of burnt materials/components was overpowering at the time of examination.

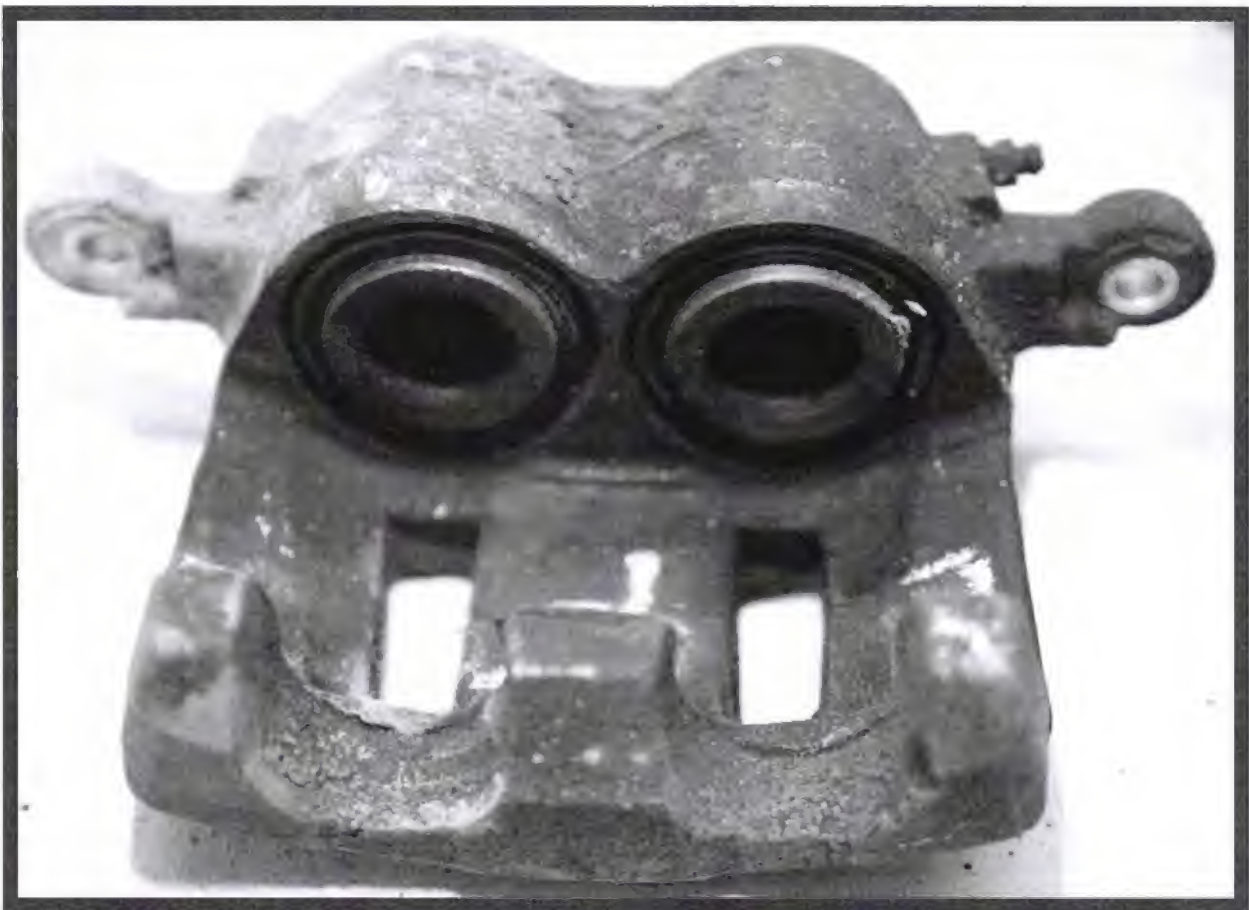
Disc Brake Caliper, Left Front – The left front disc brake caliper of the 2001 Ford Excursion stretch limousine exhibited prominent casting thermal distress with an intense odor of burnt materials/components. The flexible brake hose fitting had been sheared at the casting housing, consistent with impact forces. The two disc brake caliper pistons were of the phenolic composition, presenting proper expansion and seal retraction. The examination of the two piston bores following piston removal revealed slight scoring, slight pitting, and evidence of brake fluid contamination.

Image No.31. This photograph depicts the left front disc brake caliper of the 2001 Ford Excursion stretch limousine during the period of individual component analysis. The effects of severe thermal distress were clearly evident, including the intense pungent odor of burnt materials/components.

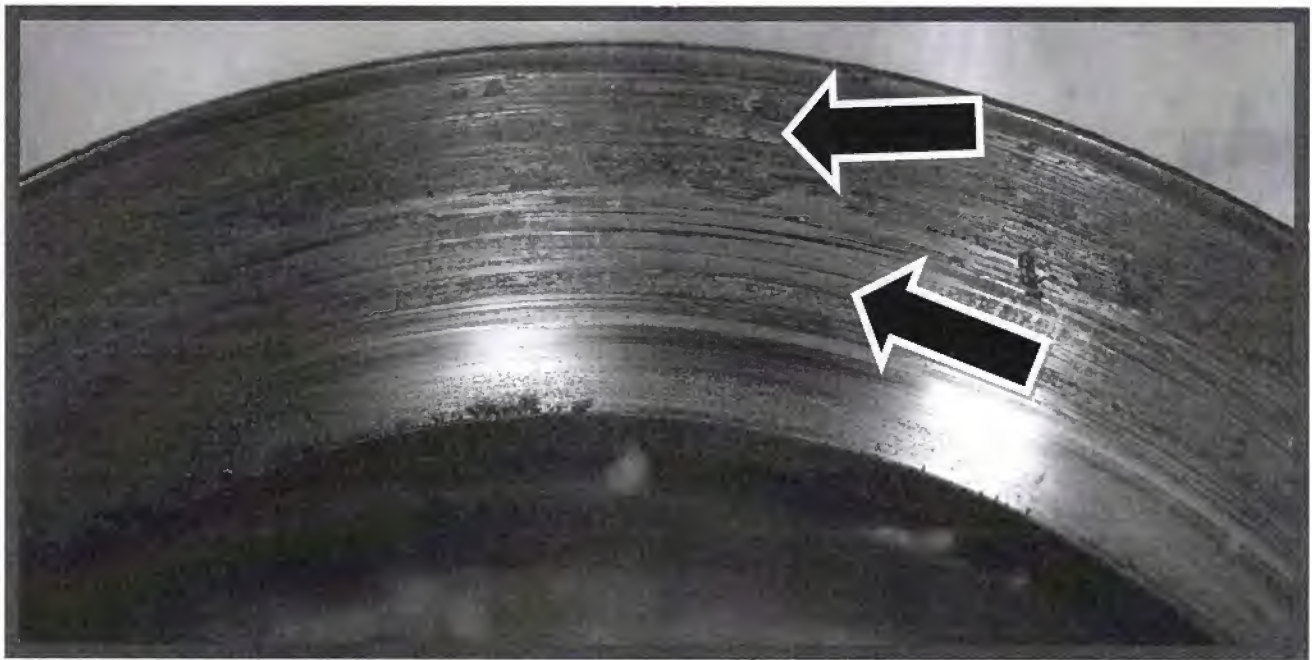
Disc Brake Rotor, Left Front – The examination and forensic analysis of the left front disc brake rotor of the 2001 Ford Excursion stretch limousine revealed that of a two piece, heavy duty, eight (8) stud hole, cast disc brake rotor. The left front disc brake rotor exhibited prominent evidence of thermal distress, with a remarkable odor of burnt materials/components.

- ✓ Outer swept area presented scoring, pitting, corrosion, and embedded brake pad friction material.
- ✓ No brake dust detected due to prior extreme component temperatures.
- ✓ Inner swept area exhibited corrosion, oxidation, pitting, scoring, and embedded brake pad friction material.
- ✓ Condition consistent with extreme thermal distress from brake effort.
- ✓ Rotor vent area exhibited hardened deposits of burnt material.
- ✓ Reduced brake component cooling due to heavy corrosion at cooling fins.
- ✓ Notable scoring, inner bearing race.
- ✓ Minimum measured left front disc brake rotor thickness = 1.502". Minimum disc brake rotor thickness specification = 1.410". Minimum disc brake rotor thickness to machine rotor specification = 1.440".

Image No.32. This photograph depicts the outer swept area of the left front disc brake rotor of the 2001 Ford Excursion stretch limousine during the period of individual component analysis. The effects of severe thermal distress were clearly evident, including embedded material consistent with thermal deterioration of disc brake pad friction material (Black Arrows).

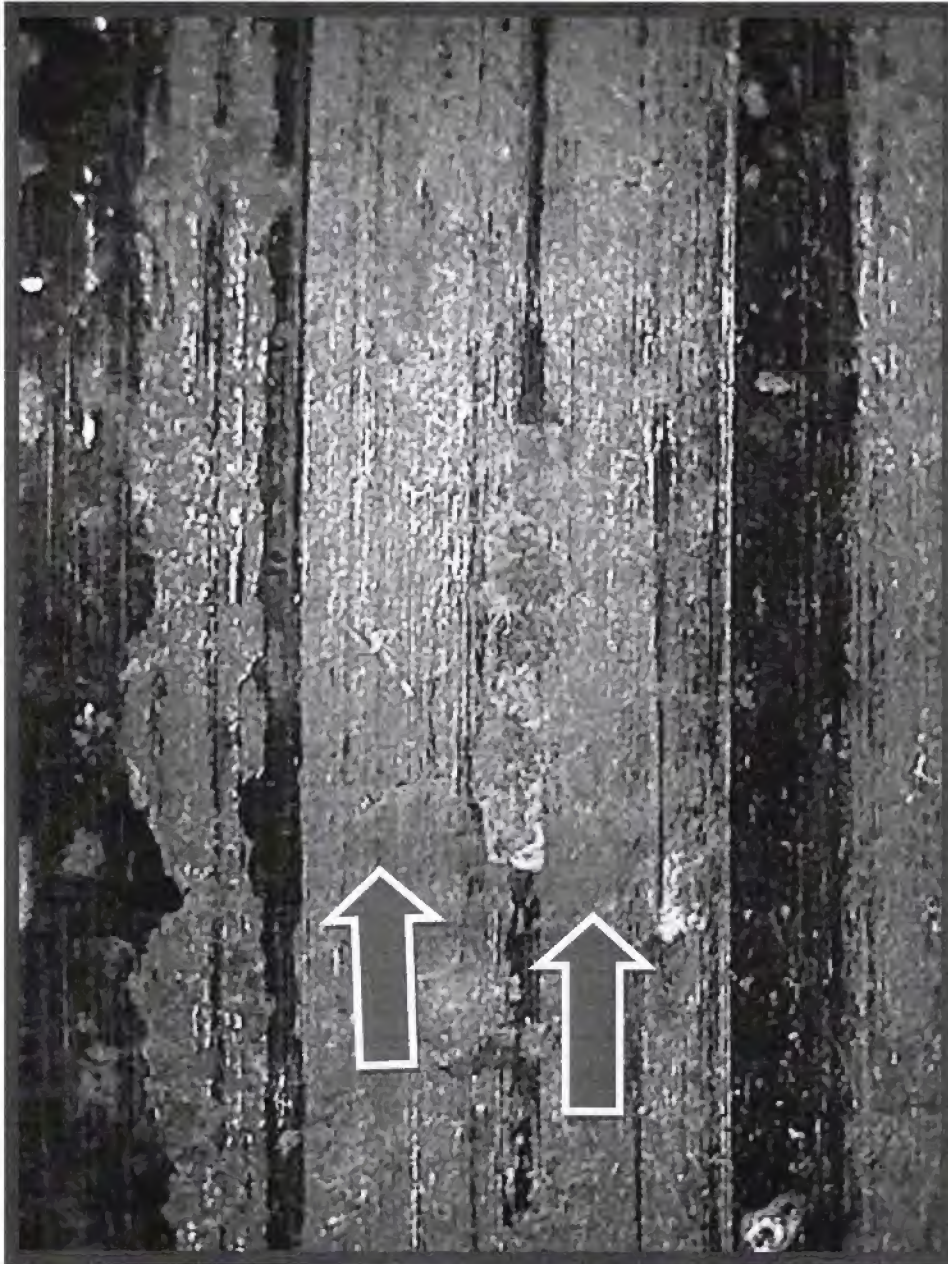
Image No.33. This digital microscope image depicts the inner swept area of the left front disc brake rotor of the 2001 Ford Excursion stretch limousine during the period of individual component analysis. The effects of severe thermal distress were clearly evident, including embedded material consistent with thermal deterioration of disc brake pad friction material (Red Arrows).

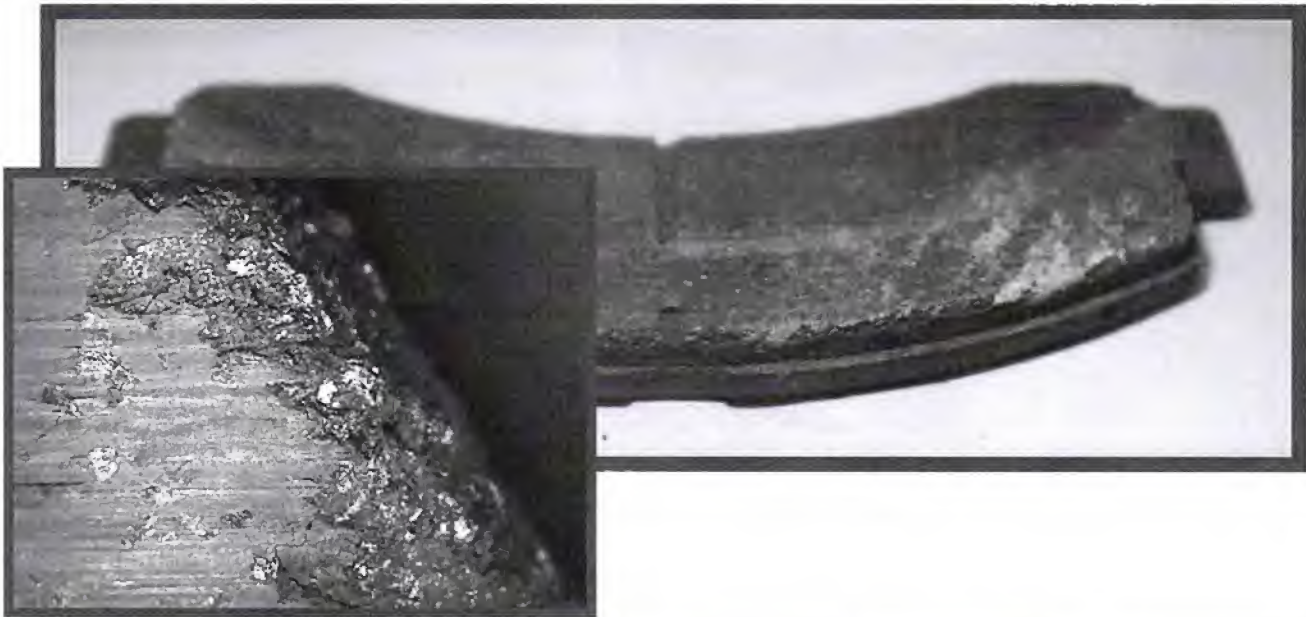
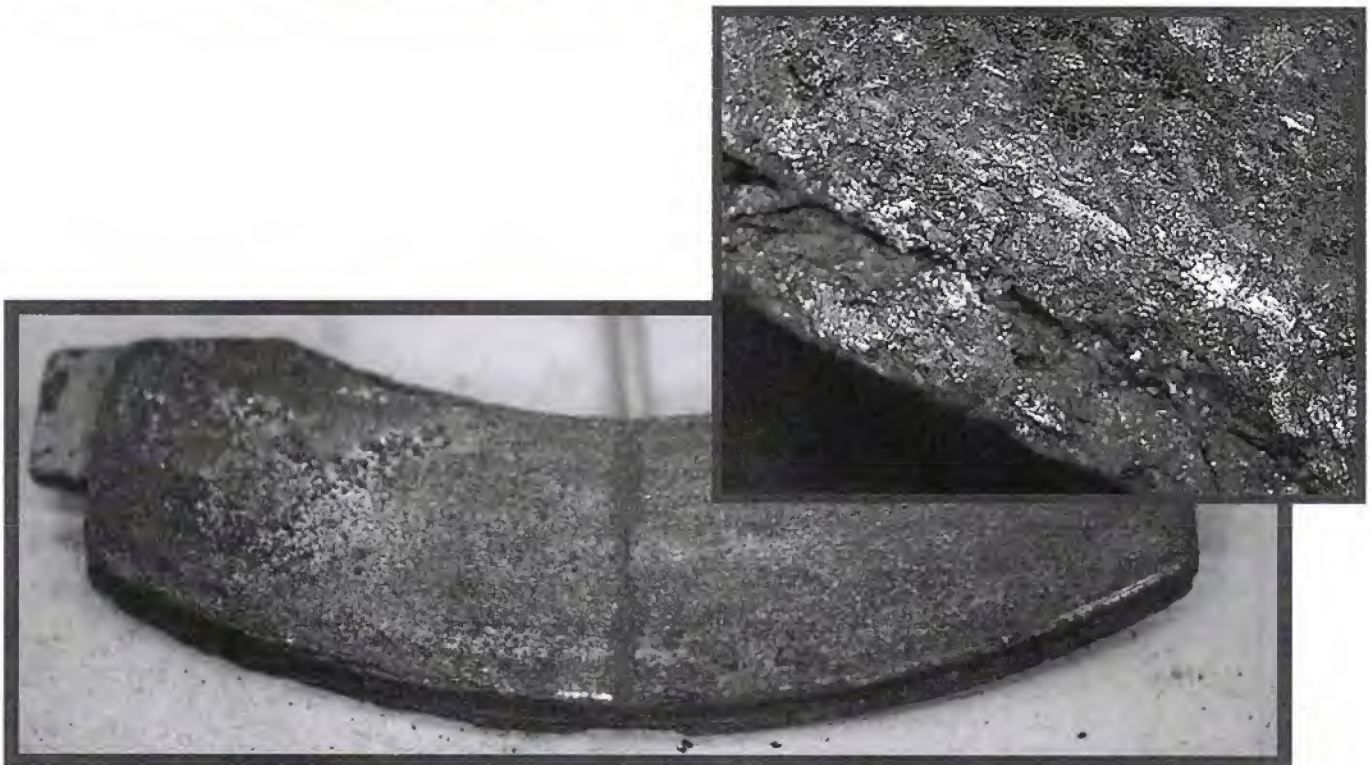
- ✓ Digital measurements of friction material thicknesses of outer disc brake pad 0.248" - 0.312", with tapered wear. Original friction material 0.443". Corrosion present at abutment clip locations.

- ✓ Digital measurements of friction material thicknesses of inner disc brake pad 0.210" - 0.281", with tapered wear. Original friction material 0.443". Corrosion present at abutment clip locations.

- ✓ Bonded design disc brake pads, semi-metallic composition.
- ✓ No brake dust detected due to prior extreme component temperatures.
- ✓ Obvious thermal distress noted, inclusive of embedded glazing deposits and obvious burnt material odor.

- ✓ Inner disc brake pad friction material exhibited embedded glazing deposits and corrosion, with onset of separation and delamination consistent with prior extreme friction temperatures.

Images No.34a & 34b. These photographs depict the outer disc brake pad friction material (above photograph, with insert) and the inner disc brake pad friction material (below photograph, with insert) of the left front disc brake pads of the 2001 Ford Excursion stretch limousine during the period of individual component analysis. The effects of severe thermal distress were clearly evident, including delamination and glazing.

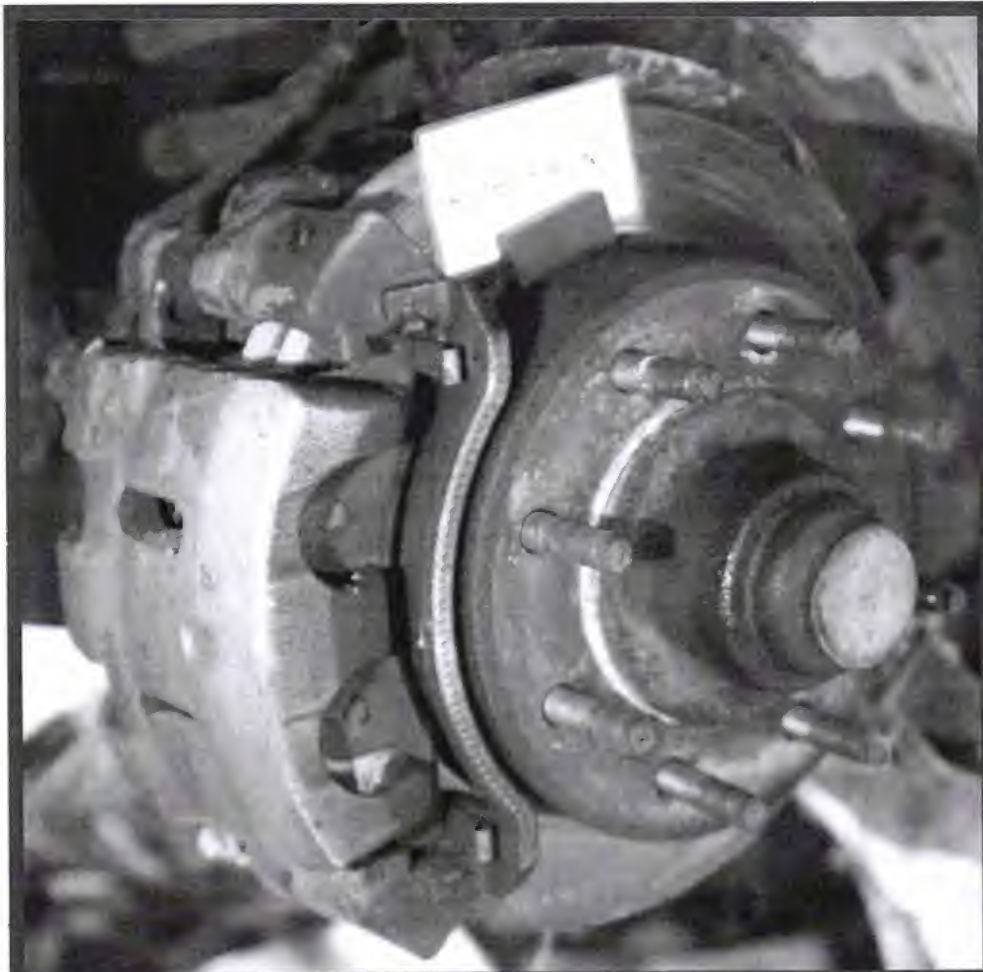
Image No.35. This photograph depicts the right front disc brake components of the 2001 Ford Excursion stretch limousine. The extreme thermal effects were prevalent, inclusive of the pungent odor of burnt materials/components which was overpowering at the time of examination.
